Why CO₂ Absorbers Go Off Spec

Ralph H. Weiland and Matthew D. Bailey
Optimized Gas treating, Inc.
12337 Jones Rd., Suite 432
Houston, TX 77070

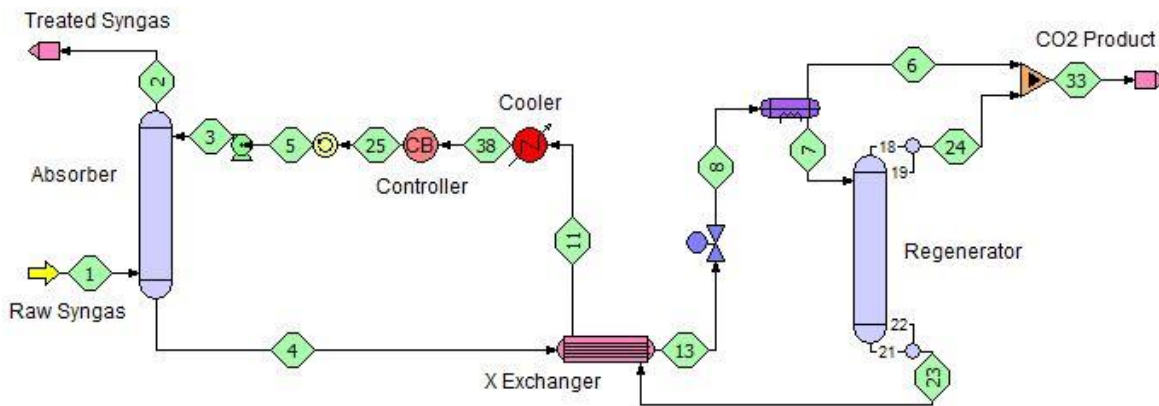
Figure 1 Simplified Process Flow Diagram for Single Recycle Case

Figure 1 shows a simplified flow diagram of this carbon dioxide removal unit which was configured with a single absorber, single regenerator, and single lean amine stream. Over time, the performance of heat exchangers deteriorates. This results in a gradual lessening of heat cross exchange in the exchanger labeled X-Exchanger so as time goes by the lean solvent slowly becomes warmer. The ability of the Cooler to provide additional solvent cooling also becomes increasingly limited. The net result is that the lean amine entering the CO₂ absorber gets hotter with increasing time-on-stream.

An additional problem with the Trim Cooler (Cooler block seen in Figure 1) is that heat exchange is usually against ambient air and regardless of the climate, summer months are the hottest time of the year. Fin-fan coolers have a set area and if cooling is controlled by fan speed, that too has an operating range which limits the maximum amount of cooling possible.

Single recycle CO₂ removal systems like the one shown here are generally simple to operate and are usually immune from rapid responses to seemingly small variations in flows and temperatures over a fairly wide operating range. In the case study considered here, the CO₂ removal unit operates in a plant producing about 1,350 tonne/d ammonia from 208,000 Nm³/h of raw syngas with 17.86% CO₂. The solvent is 42 wt% MDEA promoted with 3 wt% piperazine flowing at 375 L/s measured at the lean solvent inlet stream temperature. The reboiler in the trayed regenerator consumes 215 GJ/h provided by steam. The 12-ft (3.66-m) absorber holds a 40-ft (12.2-m) deep bed of IMTP@-50 random packing.

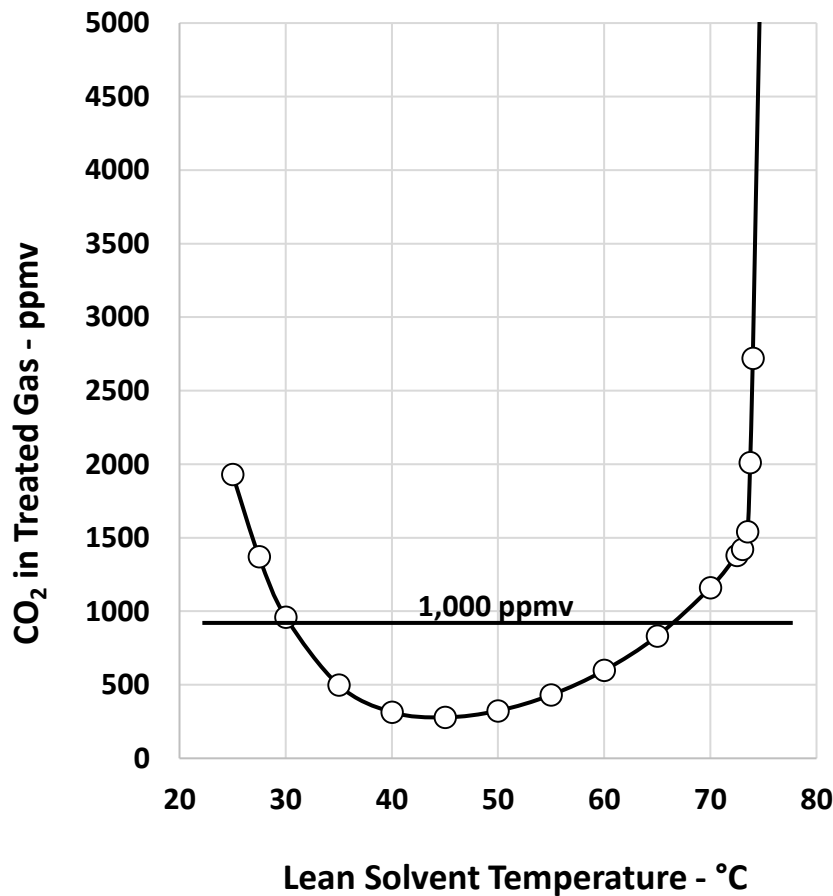
Figure 2 Treating Response to Lean Solvent Temperature

Performance as a function of lean amine temperature was assessed using the ProTreat® simulator which is completely mass and heat transfer rate based and depends on absolutely no adjustable parameters to achieve any kind of fit or agreement with measured data. Agreement with data is simply a natural consequence of the predictability of the models. Figure 2 shows the simulated response of the treated gas CO₂ level to variation in the lean amine temperature.

There is an optimal lean temperature at about 45°C. As temperature is lowered from this value treating gets worse, slowly at first, but more and more rapidly as temperature continues to fall. The cause is two-fold: the kinetics of the reaction between carbon dioxide and piperazine slows, and the solvent becomes more viscous which inhibits the absorption rate of CO₂ into the solvent. As lean solvent temperature is raised above 45°C treating again worsens.

This time it's because the equilibrium solubility of CO₂ rises with temperature. But above 73–74°C, treating starts to go badly wrong. The reason is simply because the solvent is now holding as much CO₂ as it possible can at absorber conditions. Its capacity is even lower at higher temperatures and what cannot be absorbed has to leave with the treated gas. The solvent temperature at which this happens is the breakthrough temperature and beyond it further CO₂ removal fails miserably and the treated gas goes wildly off specification. Note also that controlling to a set point temperature of 73–74°C will be quite impossible.

Too cold, and especially too hot have dire consequences; however, solvent temperature has a wide operating range, at least in this removal plant. Nevertheless, it is critical to keep the lean amine temperature below 73–74°C, something that may prove hard to do in very hot environments, especially if the exchanger has been undersized, or it has become fouled. These problems are exacerbated if plant throughput is pushed beyond reasonable levels. Sensitivity analysis by rate-based simulation is the most assured way to analyse operations and set limits before changes are implemented and promises of higher production rates are made.

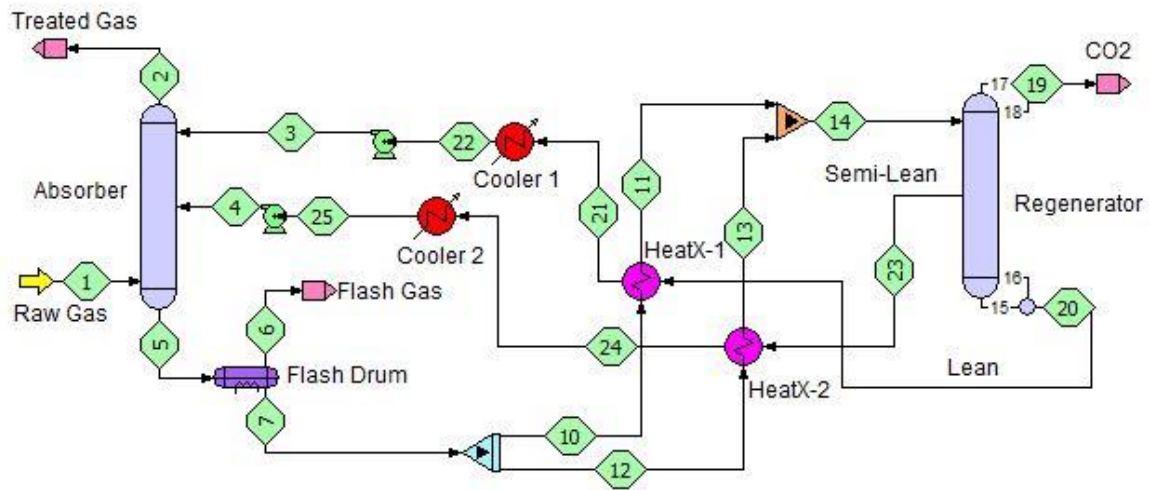
Figure 3 Split Flow CO₂ Removal Unit

This case study is of a much larger plant in the Middle East, one with a nominal 3,500 tonne/d capacity. The process is in a split-flow configuration. In a conventional split-flow plant (Figure 3), a semi-lean amine stream is drawn from part way down the regenerator, cross exchanged with part of the rich feed to the regenerator, and enters the

absorber mid tower. The remaining solvent continues down the regenerator and leaves the reboiler in a fully-stripped state. It returns to the absorber top where it removes the residual CO₂ not yet captured by the semi-lean solvent.

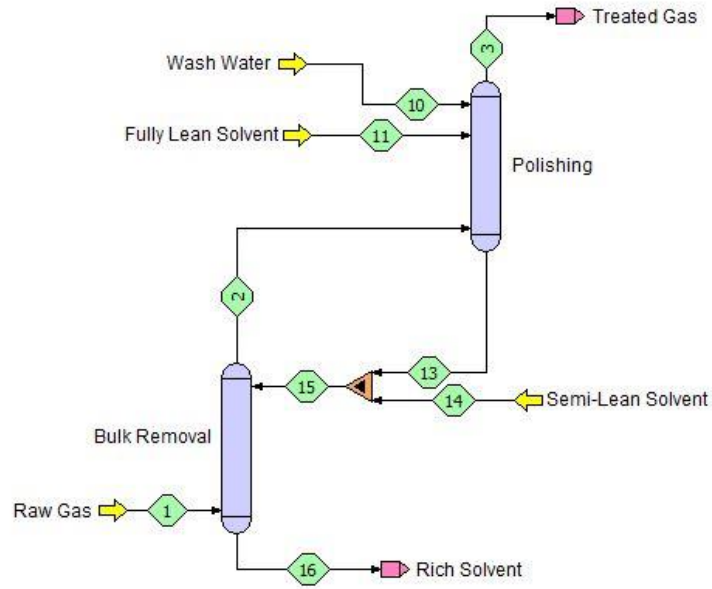
Figure 4 Absorber As-Built

In this particular plant, the single absorber is actually built as two side-by-side columns of 4-m (Polishing) and 6-m (Bulk Removal) diameter, containing different packings but each with the same 11-m total bed depth (Figure 4). The absorber was also simulated this way although ProTreat is perfectly capable of modeling this setup as a single tower, swaged at the semi-lean feed point and containing different packings. The simulation of the Polishing column included two bubble cap trays at the top which serve to capture potential solvent that would otherwise be carried over with the treated gas. Lean and semi-lean solvent flows are 770 and 4480 tonne/h, respectively. The solvent is nominally 37 wt% MDEA with 3 wt% piperazine as promoter.

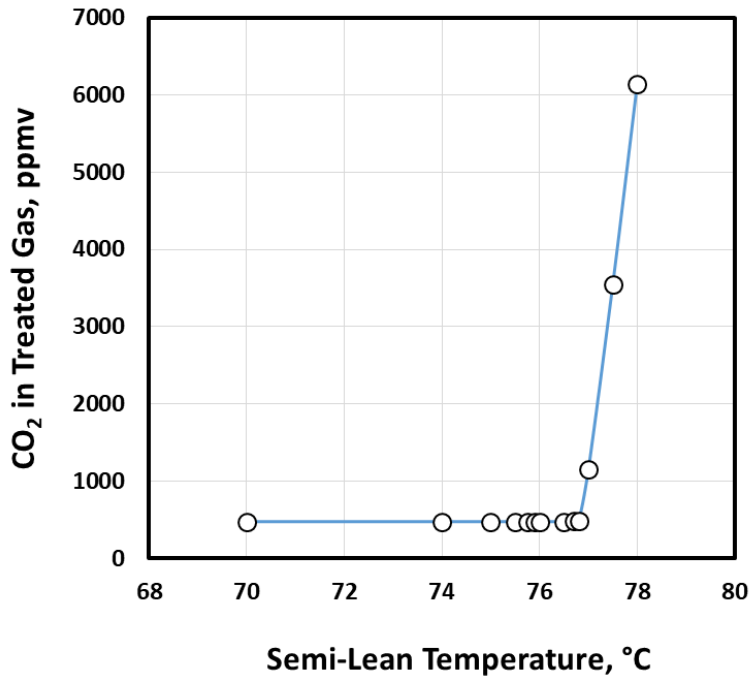
Figure 5 Response of Treating to Semi-Lean Temperature

The parameter of greatest interest is the temperature of the semi-lean solvent stream because it was the one variable the plant was having the greatest difficulty getting down to a satisfactory level. Figure 5 shows how treating is simulated to respond to semi-lean amine temperature, and the simulation predicts that the absorber system operates quite satisfactorily as long as this temperature is kept below about 77°C. Unfortunately, the trim cooler (Cooler 2 in Figure 3) was undersized for the throughput desired and in the summer months with very hot ambient air temperatures, the temperature could not be brought to below the process licensor's recommended maximum of 74°C. A higher solvent rate would have fixed this problem but the solvent pumps were already operating at capacity.

One of the interesting aspects of Figure 5 is that a unit operating below 77°C would give *absolutely no indication* of the existence of the critical temperature of 77°C, and that if it were exceeded, treating would rapidly go off specification without warning of any kind. There is a critical temperature, *not a temperature range*, and given the inherent margin in any control system, one might find sudden unexpected and inexplicable excursions in treating with a temperature change of less than 1°C.

Figure 5 shows CO₂ breakthrough from the polishing column, apparently caused by excessively high semi-lean solvent temperature. Breakthroughs of this type almost invariably correspond to a solvent capacity limit being exceeded. In the present case, as the semi-lean temperature increases the Bulk column is able to remove less and less CO₂ and what cannot be removed spills over into the Polishing Column. At conditions corresponding to 76.8°C the Polishing Column's absorption capacity has been reached and breakthrough occurs. Figure 6 shows the CO₂ content of the gas leaving the Bulk Removal column as a function of semi-lean temperature. The slow increase that can be seen below the break (~ 76.5°C) results simply from elevated equilibrium pressure caused by higher temperature. The rapid rise to the right of that temperature is the result of CO₂ breakthrough, i.e., the solvent capacity in the Bulk Removal column has been reached and then exceeded.

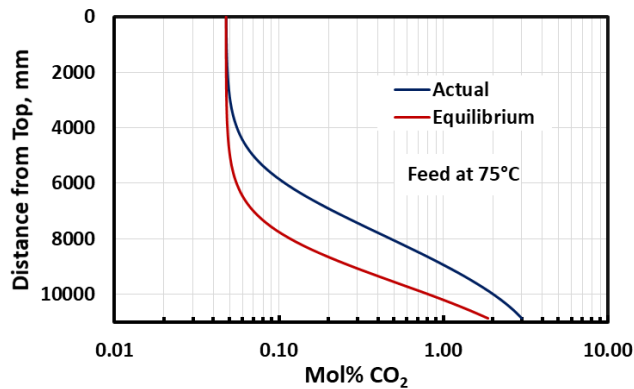
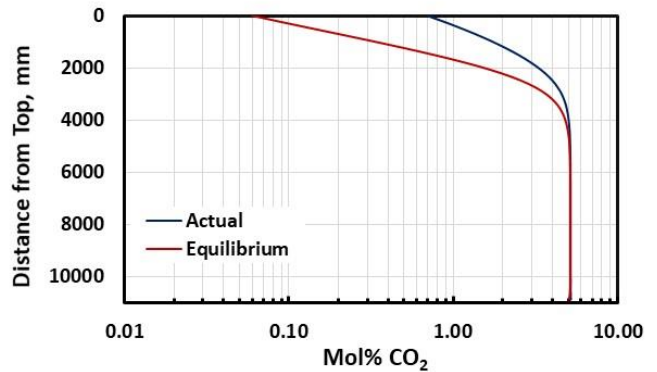
Figure 7 CO₂ from Bulk Removal Column vs. Semi-Lean Temperature

In the vicinity of 77°C, both columns go from having their performance pinched at the top, to pinched at the bottom. Figure 7 shows CO₂ profiles interior to the Polishing column before and after the switch from being lean-end to rich-end pinched. Pinching is a condition that occurs when the actual concentration of CO₂ in the gas and its equilibrium concentration coincide. When that happens, there is no driving force (no concentration difference) to force or drive absorption through mass transfer. Consequently, absorption stops and that region of the column is said to be pinched. The kind of profiles and the type of pinching shown in Figure 7 for the Polishing column occur simultaneously in the Bulk Removal column, too.

(a) Lean Pinched — Cold Semi-lean

(b) Rich Pinched — Hot Semi-lean
